## Case 417 : Narrative

Case Vehicle (A): 1998 Honda	Vehicle (B): 2000 Buick
Type: Accord LX, 4-door sedan	Type: Century Limited, 4-door sedan
Driver: 80-year-old male	Driver: 76-year-old female
CDC: 12-FREW-2	CDC: 12-FREW-2

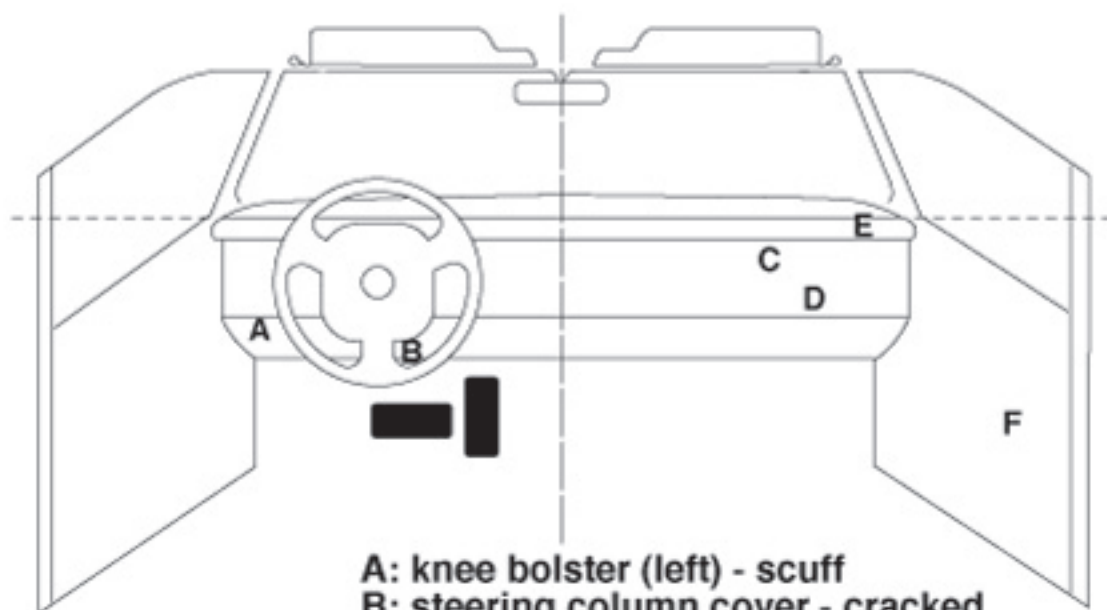
- A:** knee bolster (left) - scuff
- B:** steering column cover - cracked
- C:** glove box - ajar
- D:** bolster below glove box - cracked
- E:** vent outlet - cracked
- F:** right-front door panel - scuff
